Failure Investigation of a 6th Stage Compressor Blade on a ETF40B Gas Turbine Engine

Gerrick Slogar (Gerrick.Slogar@Vericor.com)
Vericor Power Systems Inc.
3625 Brookside Parkway Suite 500
Alpharetta, GA 30022

1 Abstract:

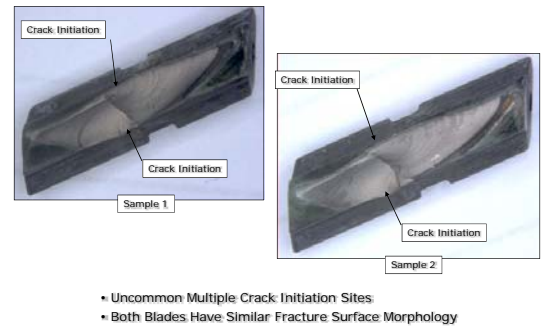
Figure 2 ETF40B 6th Stage Blade Fracture Surfaces

The fracture surfaces of the two missing 6th stage blades were visually and metallurgically interrogated to determine the failure mode and probable cause. The visual examination revealed a multiple origin transgranular fracture surface with no visible evidence of damage near the suspected origin, as seen in Figure 2. Stereomicroscopic review of the fracture surfaces revealed apparent origins near the pressure side and suction side mid-span area of both blade remnants. The pressure side origin was ~0.018” subsurface and the suction side origin appeared to be surface related, as seen in Figure 3. The fracture surface was predominantly transgranular, indicative of fatigue, with a small section of the fracture surface having an intergranular, dimpled appearance of the final overstress.

Fracture Surfaces Of Both Blades Are Similar, Uncommon Crack Initiation

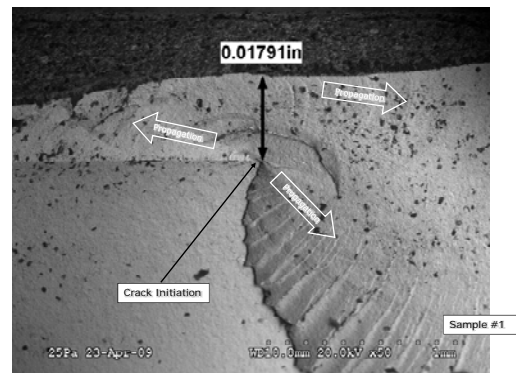
Figure 3 ETF40B 6th Stage Blade Fracture Surface Identifying Fracture Origin

High magnification metallurgical examination was conducted to confirm and supplement the visual findings using Scanning Electron Microscopy (SEM). Both blade fracture surfaces were very similar in appearance and were predominately transgranular, which is typically indicative of fatigue propagation. Near the suction side trailing edges (and to a lesser degree, the pressure side leading edge area) a small area was observed that was intergranular and contained ductile dimple type overstress features. These intergranular areas were the final overstress regions when the airfoil separated from the two

Subsurface Crack Initiation on Pressure Surface With Fatigue Propagation

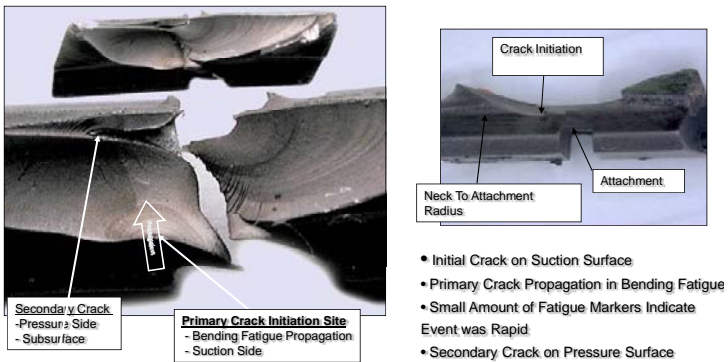
Figure 4 ETF40B 6th Stage Blade Fracture Surface Showing Multiple Origins

Close examination of the root section from Sample 1's blade revealed the crack to propagate under the primary fracture surface, therefore the sample was broken open for close examination, as seen in Figure 4. Once the sample was broken open, it was apparent the primary crack propagated from the suction surface. There was a secondary crack initiation on the pressure surface. Both of the cracks propagated in opposite directions giving an appearance of a torsional failure mode. Based on the fracture surface and the multiple initiation sites, it can be concluded that the part saw high levels of fundamental cantilever bending mode stresses resulting in ultimate liberation of the airfoil.

Primary Crack Initiation on Suction Surface In Neck To Attachment Transition

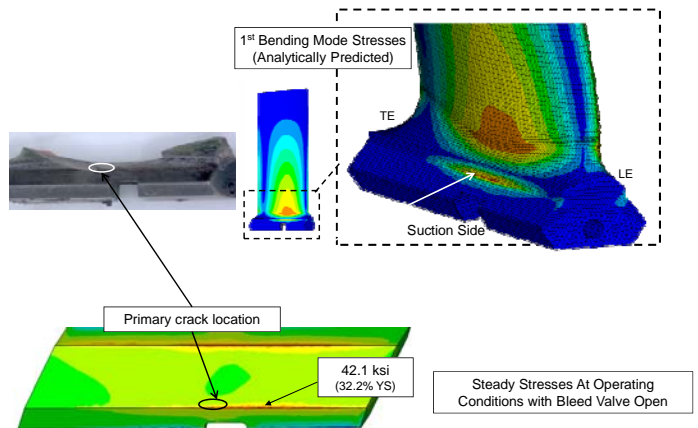
Figure 5 6th Stage Blade Structural Analysis Predictions of High Stresses in Crack Initiation Area

The 6th stage blade model was finely meshed in the airfoil root attachment area to accurately predict static stresses. Once the ANSYS model was prepared and boundary conditions applied, the analysis was run at maximum operating conditions to determine the highest static loading in the part. The model results output were posted to allow for a fillet at the cross section of the primary crack location. The stress highest in the crack initiation area and can be seen in Figure 5

Modal stress predictions show the highest stress to be at the primary crack location for the 1st bending mode. All other predicted resonant mode stress did not generate high stresses in the primary fracture location. Therefore, the analysis corroborated the metallurgical findings indicating a high deflection simple bending mode fracture. The first bending or simple cantilever bending mode on the part produces similar vibratory stress on the suction and pressure surfaces, further corroborating the failure mode.

Analytical Modeling Predicts High Bending Modal Stresses at the Crack Initiation Site

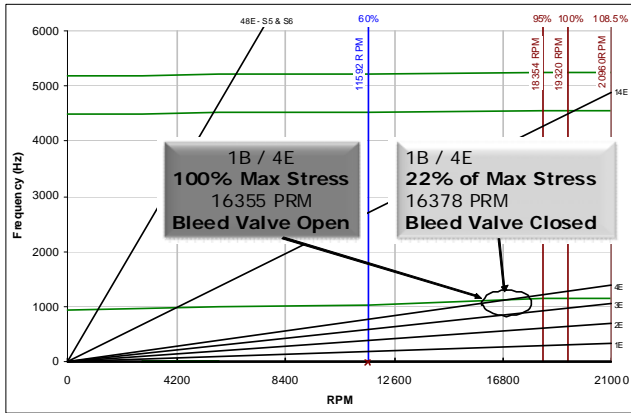
Figure 6 6th Stage Blade Campbell Diagram with Test Data

This resonant response was determined to be the first bending mode driven by a 4 per revolution (4E) driver at approximately 16300 RPM. The maximum measured vibratory stress was normalized to be considered 100% of the maximum measured stress as seen in Figures 6 and 7. Figure 6 plots the resonance on the Campbell Diagram. This level of vibratory stress combined with the steady stress when plotted on a Goodman Diagram above the Goodman Limit, as seen in Figure 7. The 1st bending mode also showed a 6E response, with a lower stress measuring only 22% of the maximum measured stress at 9778 RPM. The significance of this resonant crossing is that it appears there is a strong 2 per rotor revolution (2E) driver in the engine

August 2009 Instrumented Test Identified Fracture Mode of 6th Blade

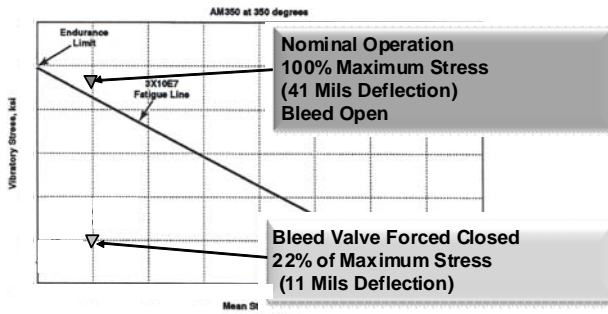
Figure 7 6th Stage Blade Goodman Diagram

High resonant stresses were observed on the 6th stage blade during normal operation of the engine. The stress on the 6th stage blade was determined to be driven by the compressor surge bleed system. The resonant crossing occurred at low power. No significant responses were noted on any part at high power throughout the test. A summary of the test results can be seen on the Campbell diagram in Figure 6. Figure 7 Summarizing the 6th Blade stresses on the Goodman diagram. This shows the measured stresses to be of concern.

Instrumented Test Validated 6th Blade Stresses

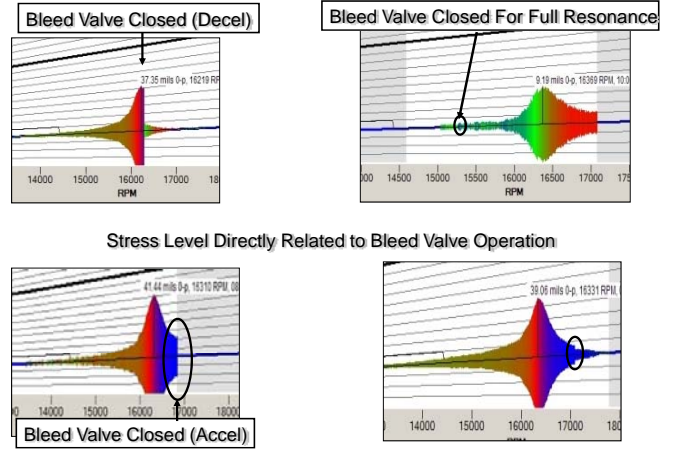
Figure 8 6th Stage Blade 1st Bending 4E Resonance Response with Bleed Open and Closed

Data reduction indicated that during a deceleration, the resonance would abnormally be excited as the engine transitioned from high speed through the speed zone of concern, as seen in Figure 8. It was determined this resonance change was related to the bleed valve opening on deceleration. It was concluded the bleed valve was the primary resonant driver. Therefore, further exploration of the resonance was conducted to determine if the resonance was driven by the exiting of bleed air from the bleed valve. This was completed by performing a normal start and forcing the bleed to be closed prior to the resonant speed zone of concern, 16128 to 16640 as illustrated in Figure 8. The 1st bending 4E resonant crossing occurred at the same speed zone, but the stresses were substantially reduced to a maximum observed stress of only 22% of the maximum stress observed with the bleed open. Plotting this stress level on the Goodman diagram shows the stress to be well within the Goodman allowable, as seen in Figures 6 through 9.

Bleed Valve Operation Is Directly Related to Stress Level

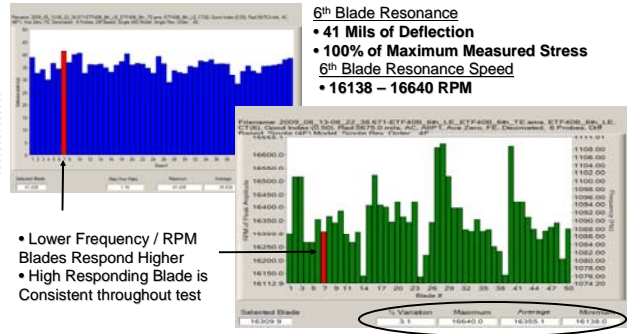
Figure 9 6th Stage 1st Bending 4E Individual Blade Deflections

Figure 9 is an additional plot of the deflection on each of the 6th stage blades in a given revolution, the deflections are considered consistent from blade to blade and within expected results, with no anomalous blade response. The speed zone

of the resonance is also defined in this figure from 16128 to 16640. The variance in resonance speed is primarily driven by the geometric tolerances between each airfoil in the wheel. No high or abnormal resonances were observed at high speed/power, throughout the test.

ETF40B Strain Gage Results Show Resonance Speed Variation of 3.1%

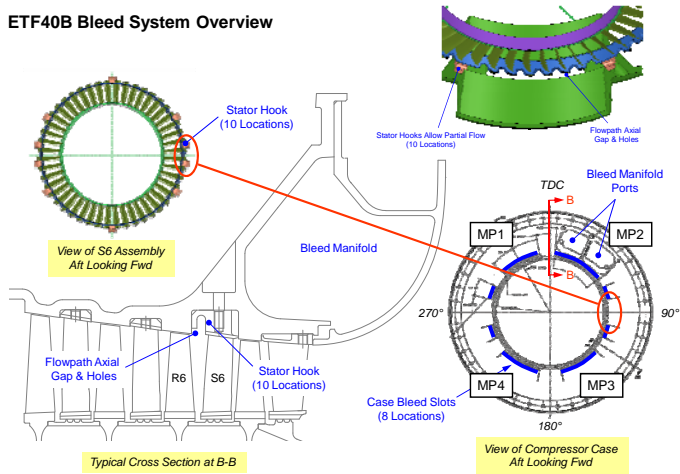
Figure 10 ETF40B 6th Stage Bleed Configuration

engine's bleed systems could account for the higher ETF40B stress levels. The ETF40B and TF40 bleed configurations can be seen in Figures 10 and 11. Figure 12 is a graphical depiction of the port size and quantity differences between the TF40B and the ETF40B. It can be seen that there are fewer and larger ports on the ETF40B. A comparison of the flow area for each of the bleed system components concluded the area at the flow path to be the same but elsewhere in the system showed significant differences in flow area and configuration. This can be seen in Figure 12. The flow area of the flow path consists of half circle cut outs forward edge between each vane and a gap between the forward edge of the stator and the compressor case. The 6th stator is attached to the compressor case by retention hooks, Figure 10, on the stator. The retention hooks are not in the same location for the TF40 and the ETF40B due to the configuration of the bleed slots. The hooks tend to separate the bleed flow into sections through each bleed slot.

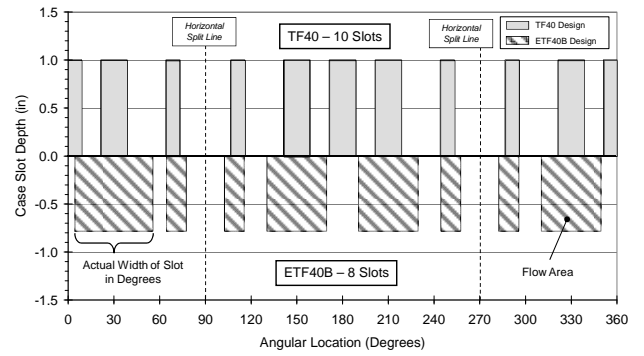
Figure 12 Compressor Case Bleed Port Comparisons between the ETF40B and the TF40

TF40 / ETF40B Case Bleed Slot Flow Area Comparison

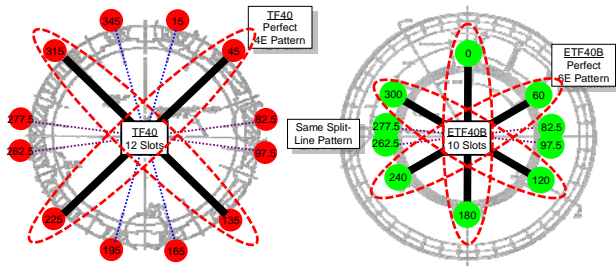
Figure 14 ETF40B and TF40 Configuration

The initial results from the Fourier analysis of the TF40 compared to the ETF40B showed that the 4E driver was significantly stronger in the ETF40B as compared to the TF40, as seen in Figure 15. The results were interrogated to understand the 4E driving function in the ETF40B, or the lack of the 4E driver in the TF40. It was discovered that the TF40 bleed port design generated two 4E signals that are out of phase with each other, thus the two signals cancel each

other resulting in lower overall amplitude of the 4E driver in the TF40, as seen in Figure 14. The ETF40B configuration created a 4E and a 6E pattern with the 4E signal prediction being larger than the 6E, these results can be seen in Figure 14. Additionally, the ETF40B 4E and 6E configuration could potentially amplify each other as compared to the signal cancelation that occurs in the TF40.

- Driver Pattern Comparison Between the TF40 and the ETF40B shows a Significant Pattern Difference in the Bleed Port Design
- TF40 Pattern Generates a Two Out of Phase 4E Patterns that Cancel Each other Out
- The ETF40B Generates a 6E Pattern

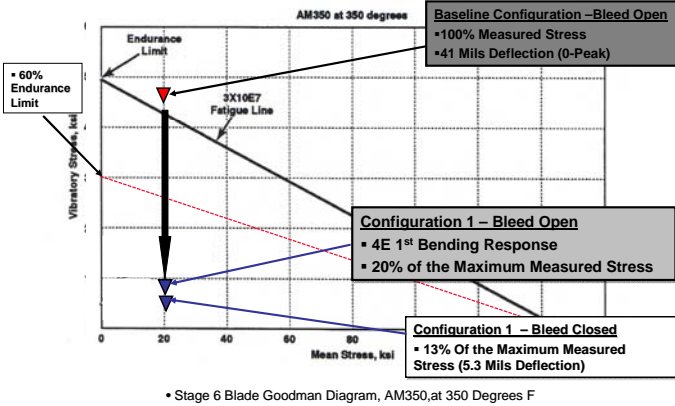
Figure 18 6th Blade Goodman Diagram Comparing the Baseline Stress to the Final Blocker Plate Configuration

Converting the blade tip deflections to blade stresses was completed by employing the results from the ANSYS structural analysis. A correlation was made between tip deflection and stress at the 6th blade root in the 1st bending modal results. Once the relationship was established, all the tip deflections were converted into maximum stresses at the root location. The vibratory stress was then plotted with the predicted steady stress from the ANSYS structural model on a Goodman diagram, as seen in Figure 18. The 4E and 5E modal stress was plotted on this diagram. Both the 4E and the 5E stresses are well within the 60% Goodman capability. This Goodman Diagram also shows the substantial decrease in vibratory stress with the final configuration blocker plates for the 4E response.

Blocker Configuration Successfully Reduces Stresses to Acceptable Levels

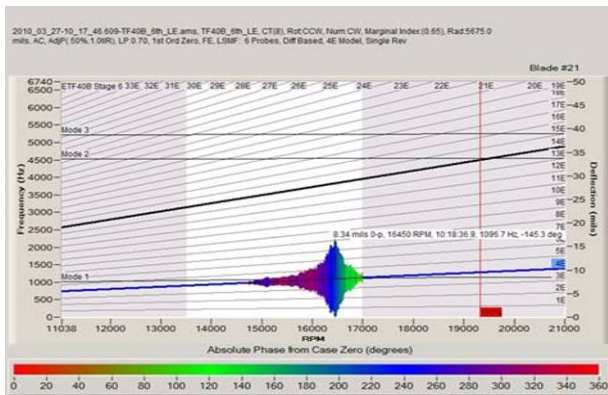
Figure 19, 6th Blade Resonance with the Final Plate Configuration – Bleed Open

4E 1st Bending Resonance Reduced to Low Levels

Characteristics of the Response Identical to Baseline Response Speed Region

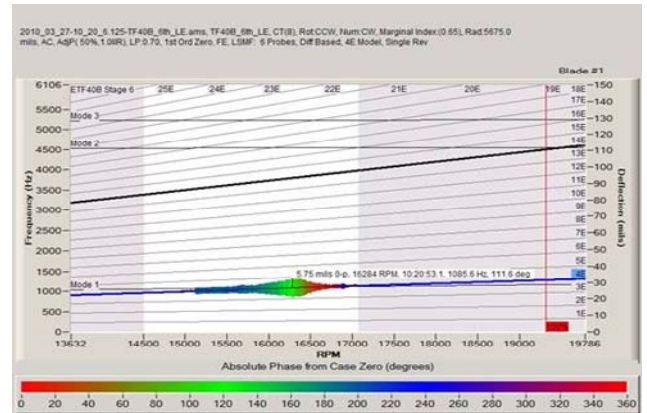
Figure 20, 6th Blade Resonance with the Final Plate Configuration – Bleed Closed

6th blade stresses with the bleed closed were acceptable as seen in Figure 28 and Figure 20. The baseline tip deflections and stresses that were taken during the August 2009 test are considered acceptable. The stresses measured during this test further reduce the levels in every blocker plate configuration.

Bleed Valve Closure Further Reduces Response To Low Levels

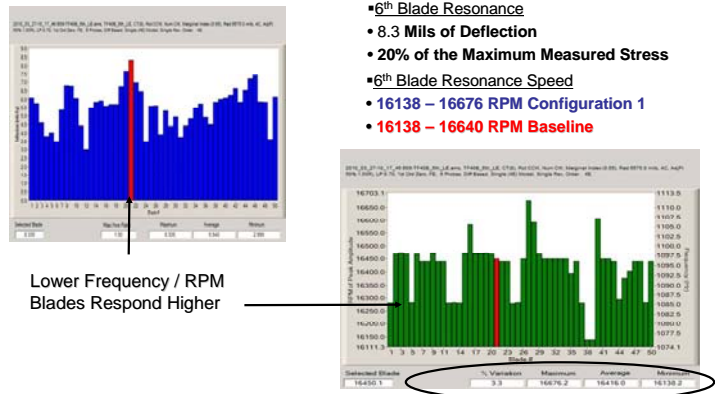
Figure 21, 6th Blade 1st Bending Response

The 4E / 1st Bending response that was recorded during this test is the same response and driver of the response that was identified in the initial test in August 2009. Figure 21 contains the individual blade specifics for the speed of the resonance, the amplitude comparison between each blade, and the response with the bleed open and the bleed closed.

Resonance Characteristics (Speed and Frequency) Identical to Baseline With Reduced Deflection and Stress
