Failure Investigation of a 6th Stage Compressor Blade on a ETF40B Gas Turbine Engine

Gerrick Slogar (Gerrick.Slogar@Vericor.com)
Vericor Power Systems Inc.
3625 Brookside Parkway Suite 500
Alpharetta, GA 30022

1 Abstract:

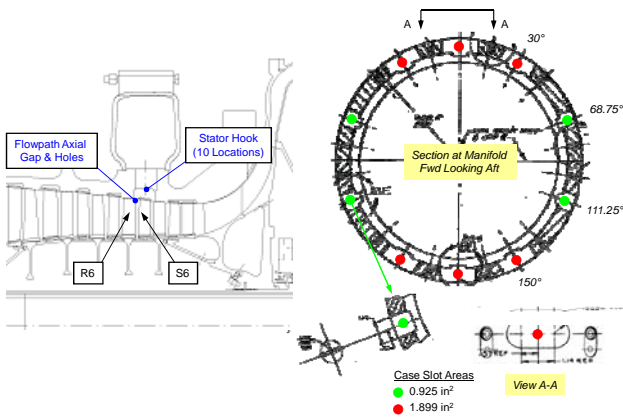
Figure 11 TF40 Bleed Configuration

engine's bleed systems could account for the higher ETF40B stress levels. The ETF40B and TF40 bleed configurations can be seen in Figures 10 and 11. Figure 12 is a graphical depiction of the port size and quantity differences between the TF40B and the ETF40B. It can be seen that there are fewer and larger ports on the ETF40B. A comparison of the flow area for each of the bleed system components concluded the area at the flow path to be the same but elsewhere in the system showed significant differences in flow area and configuration. This can be seen in Figure 12. The flow area of the flow path consists of half circle cut outs forward edge between each vane and a gap between the forward edge of the stator and the compressor case. The 6th stator is attached to the compressor case by retention hooks, Figure 10, on the stator. The retention hooks are not in the same location for the TF40 and the ETF40B due to the configuration of the bleed slots. The hooks tend to separate the bleed flow into sections through each bleed slot.

TF40 Bleed System Overview

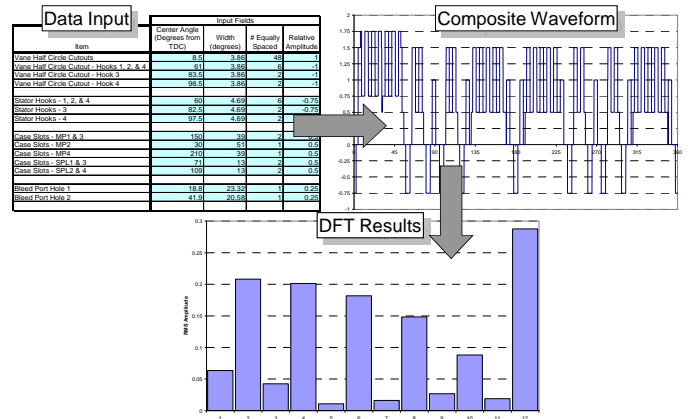
Figure 13 Fourier Analysis Model

A detailed Fourier analysis of the TF40 and ETF40B hardware configurations was generated to identify hardware configuration differences that would generate a 4E driver. The basic input parameters and methodology is seen in Figure 13. This analysis proved to be instrumental in understanding the 4E driver and ultimately reducing the 6th blade 4E 1st bending resonant stresses. The Fourier analysis evaluated the blockages in the bleed port, including the 6th vane attachment hook and half circles, bleed port size and location. Experimental engine data obtained from a previous test was not adequate to separate the effects of the 6th vane retention hook and the half circle cut outs in-between each airfoil; therefore the analysis included the effects of these features, as seen in Figure 10.

Data Input used to Construct Waveforms and Generate Predicted Fourier Results
